Oversensing Associated with Seal Plug Integrity

SUMMARY

Products Referenced

All Boston Scientific ICDs and CRT-Ds

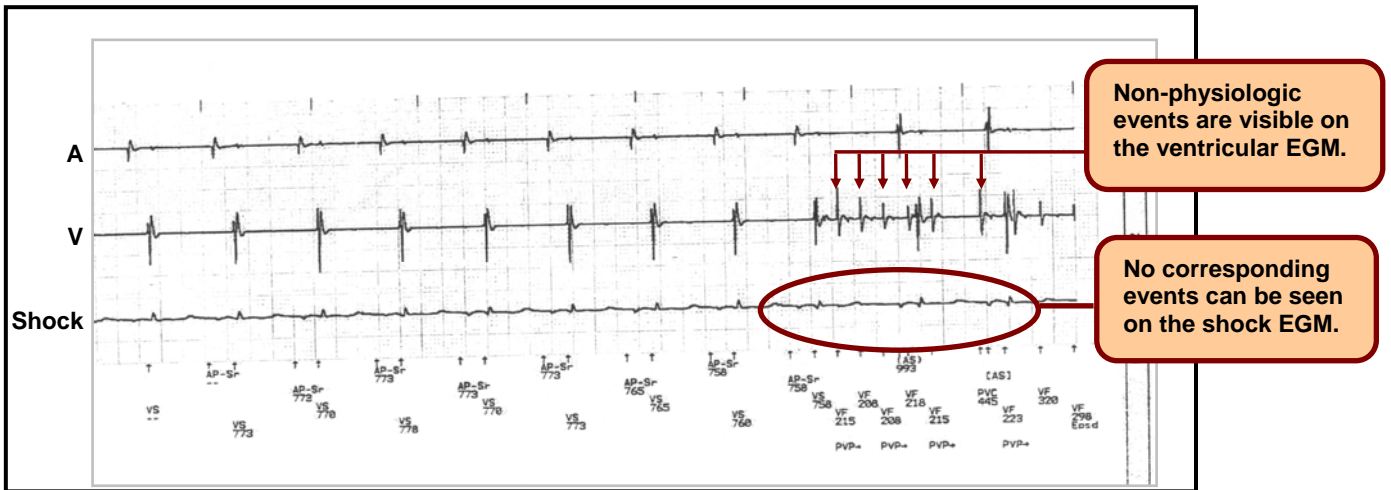
The silicone rubber used for seal plugs has a "shape memory". Inserting a wrench to operate a setscrew stretches the rubber, and seal plugs may require a short time to reseat following removal of the wrench. Until the seal fully closes, infiltration of body fluid from the implant pocket into the device header may create a temporary accessory sensing pathway. If air is trapped in the header during the lead insertion process, it may escape through the seal plug, momentarily displacing body fluid and disrupting the conductive accessory pathway. This momentary disruption causes a change in impedance of the accessory pathway, which generates an artificial (non-physiologic) noise signal capable of inhibiting pacing pulses. Oversensing of this type is sporadic and unlikely to cause either extended inhibition of brady pacing or inappropriate shocks in a defibrillator. This form of oversensing is rarely seen beyond implant and disappears once the seal plug returns to its normal closed position, the entrapped air has dissipated, and pressure equilibrium within the header has been achieved^{1, 3, 4, 5}.

Figure 1 provides an example of oversensing caused by air escaping through a seal plug following wrench insertion. Depending on which seal plug is compromised, this type of non-physiologic noise may appear on the atrial or ventricular EGM, with no corresponding event appearing on the shock EGM or on the surface electrocardiogram (ECG). The noise signals appear as single events of short duration, similar to intrinsic heart activity. One deflection is created for each escaping air bubble. **NOTE:** These noise signals are different in appearance than other physiologic signals (such as pectoral or diaphragmatic signals), which typically demonstrate more erratic amplitude and frequency characteristics (Figure 2).

Figure 1. EGM indicating non-physiologic oversensing due to air bubbles escaping header through seal plugs.

If sporadic oversensing of this type is observed, it will typically resolve spontaneously without intervention within 24 hours after initial presentation.

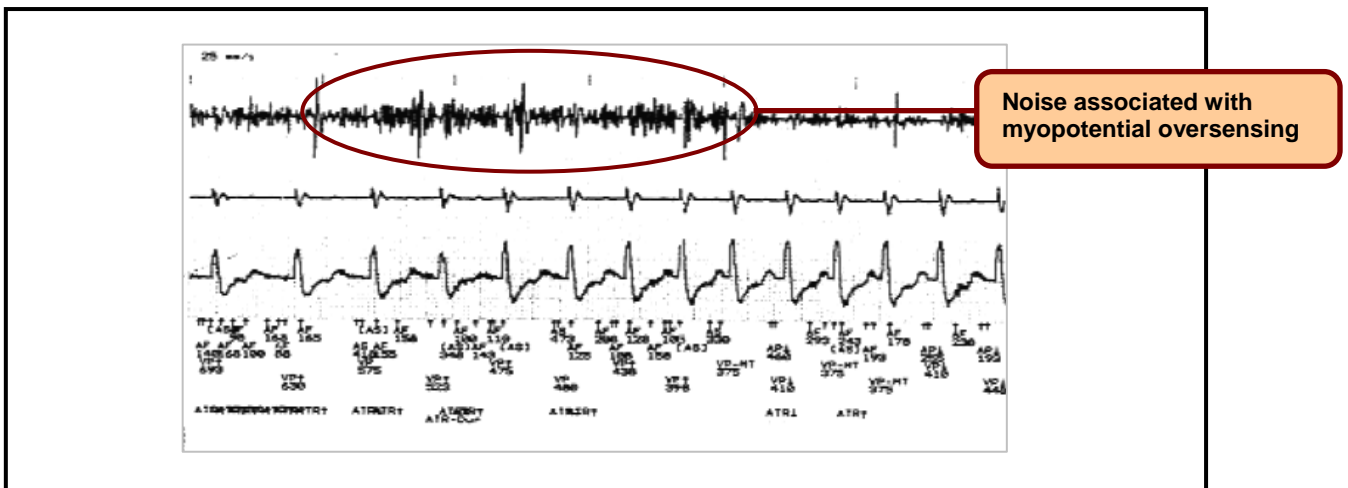
Figure 2 provides an example of oversensing of pectoral myopotentials when a seal plug is damaged (torn) or is missing altogether. The accessory sensing pathway caused by significant seal plug damage may cause chronic oversensing of skeletal/pectoral muscle signals. This type of oversensing is typically visible on stored EGMs viewed at implant or during routine patient follow-up. Signals associated with this type of seal plug damage are typically irregular in frequency and amplitude and occur for more cardiac cycles^{6, 7}.

Figure 2. Example of oversensing of pectoral muscle activity due to significant atrial seal plug damage.

Oversensing of pectoral muscle activity facilitated by seal plug damage may cause extended pauses in pacing, asynchronous pacing (noise mode) or unnecessary shocks. Standard troubleshooting procedures should be followed to identify and correct oversensing of this type, keeping in mind that other causes, such as lead insulation abrasion, loose setscrews, sub-optimal lead position and lead conductor fracture can yield similar clinical observations and are other plausible root causes to be considered.
