## Important Programmer Information

**Programmer Software Information July 2022** - Continued use of older Model 2868 software on Model 3120 ZOOM™ programmers to support transvenous CRT-Ds and ICDs until supply constraints on newer programmers<sup>1</sup> are resolved. See Table 1 for affected GTINs.

Continued use of Model 3120 ZOOM Programmers for Interrogation of Transvenous Defibrillators

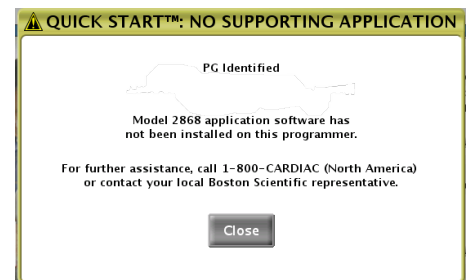
**Figure 2.** Message that displays when a Boston Scientific TV defibrillator is interrogated by a 3120 ZOOM programmer if 2868 software is uninstalled.

The behavior most likely to be attributed to potential harm when using a 3120 ZOOM programmer is the inability to interrogate a TV defibrillator (e.g. Figure 2 or 3). There have been 9 reports of this behavior which have resulted in a delayed/prolonged procedure until the defibrillator can be interrogated with a 3300 LATITUDE programmer. Furthermore, there has been a single report of delays in reprogramming for phrenic nerve stimulation and a single report of an inability to interrogate for delivery of commanded therapy. None of the reports associated with 3120 ZOOM programmer have resulted in permanent injury.

- 1) If unable to interrogate a TV defibrillator with a 3120 ZOOM programmer, use a 3300 LATITUDE programmer instead. If this behavior occurs, STAT PACE, STAT SHOCK, and DIVERT THERAPY programmer operations<sup>4</sup> are not available through a 3120 ZOOM programmer, so external pacing/defibrillation or magnet application (to divert shock) may be required if a 3300 LATITUDE programmer is not immediately available.

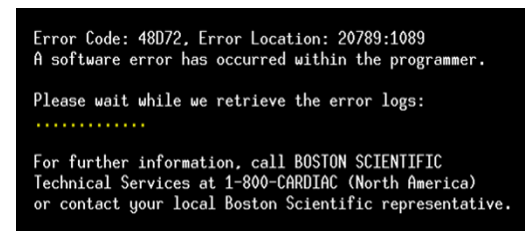
If a TV defibrillator has a stored SAM episode, the 3120 ZOOM programmer will present the Error Log and Halt message in Figure 3, and the user will need to use a 3300 LATITUDE programmer to interrogate the defibrillator. This error message (Figure 3) is an indication of an incompatibility of any 3120 ZOOM programmer with that specific TV defibrillator. However, the TV defibrillator will operate as intended with the permanently programmed settings. After power cycling the programmer, it may be used to interrogate TV defibrillators without stored SAM episodes. If the user attempts to interrogate the same TV defibrillator with the 3120 ZOOM programmer, the Error Log and Halt message will display again.

**Figure 3.** The specific Error Log and Halt Message on 3120 ZOOM Programmer when interrogation of TV defibrillator with a SAM

A 3120 ZOOM programmer update to 2868 software has been developed to resolve the Error Log and Halt behavior associated with TV defibrillators having a stored SAM episode. This software update does not represent a material
