URGENT MEDICAL DEVICE INFORMATION

Update to May, 2006 *Product Advisory*

January 4, 2008

Cardiac Rhythm Management

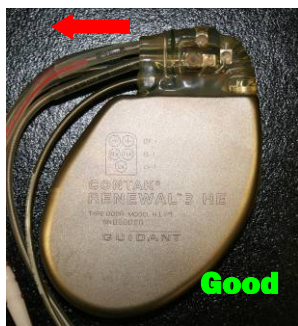
Figure 1. Optimal orientation for subpectoral implants. Leads exit in a counter clockwise direction. Serial number is facing *away* from the ribs.

3. For future implants, when considering subpectoral implantation of a device from any product family listed in Table 1, orient the device with the serial number facing away from the ribs (Figure 1).

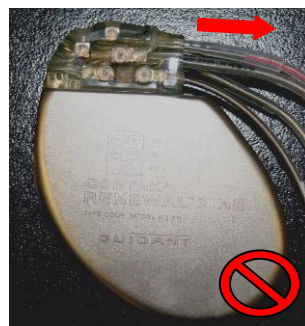
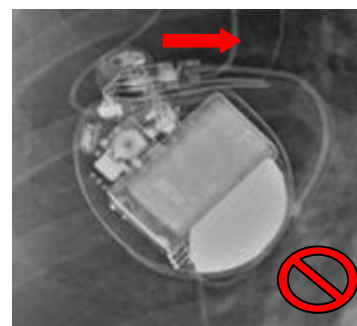
Issue: Repetitive mechanical stress applied to the titanium case can induce component damage and device malfunction in certain ICD and CRT-D devices implanted subpectorally with the serial number facing the ribs (susceptible orientation shown in Figure 2). Devices implanted subcutaneously or in a subpectoral position with the serial number facing away from the ribs are not included in this advisory. **This update identifies additional VITALITY® ICD models (Table 1) that are also subject to this failure mechanism if implanted in a susceptible orientation.**

Accelerated life testing has shown that repetitive mechanical stress applied to the serial number side of the titanium case can induce component damage and device malfunction. This has occurred *only* when the device was implanted subpectorally with the serial number facing the ribs (Figure 2).

Figure 2. Photo and X-ray. Avoid this orientation for subpectoral implants. Leads exit in a clockwise direction. Serial number is facing the ribs.

Actions: Review patient records to determine if device was implanted subpectorally. Use an AP radiograph to determine specific device orientation. If a subpectoral implant is in a susceptible orientation, consider repositioning or replacement for physically active patients or for patients who regularly need device therapy. Follow patients with susceptible devices at 3-month intervals in accordance with device labeling.
