## URGENT MEDICAL DEVICE SAFETY INFORMATION & CORRECTIVE ACTION

May 12, 2006

Subject: VITALITY<sup>®</sup> HE implantable cardioverter defibrillators (ICDs) and CONTAK RENEWAL<sup>®</sup> 3 and 4 cardiac resynchronization therapy defibrillators (CRT-Ds) implanted beneath the pectoral muscle in an uncommon orientation.

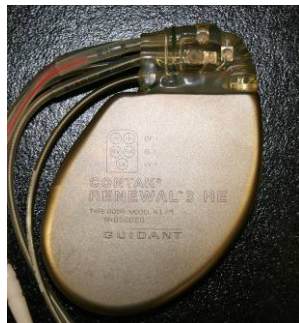
**Figure 1.** Optimal orientation for subpectoral implants. Leads exit in a counter clockwise direction. Serial number is visible at implant.

Due to component location, damage associated with this failure mode will not occur in a subcutaneous position. Similarly, the failure will not occur in devices implanted in a subpectoral position with the serial number facing up (Figure 1).

If the patient's device was implanted subpectorally and leads exit the pulse generator in a **counter clockwise** direction as shown in Figure 1, no change to your current patient management is necessary.

2. For future implants, when using subpectoral implantation of a device from any product family listed in Table 1, orient the device with the serial number facing away from the ribs, as shown in Figure 1.

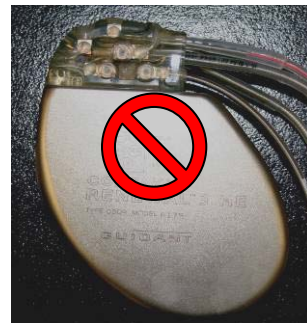
Two reports of malfunction were associated with subpectoral implantation of devices in certain families of ICDs and CRT-Ds (see Table 1). Accelerated life testing has shown that repetitive mechanical stress applied to a specific area of the titanium case can induce component damage and device malfunction. This can occur **only if the device is implanted subpectorally with the serial number facing the ribs**. As shown in Figure 2, an anterior/posterior (AP) radiograph can be used to determine device orientation.

**Figure 2.** Avoid this orientation for subpectoral implants. Leads exit in a clockwise direction. Serial number is facing the ribs.

The following model numbers are affected by this communication. Only device families listed in Table 1 that have been implanted subpectorally with the serial number facing the ribs (Figure 2) are subject to this issue.

1. For patients with a subpectoral implant, use an AP radiograph to determine device orientation. If the device is in a susceptible orientation, the patient should be advised of the potential for device failure, and patient follow-up at least once per quarter is recommended in accordance with device labeling. Consider device replacement for muscular or active patients or for patients who regularly need device therapy.
