July 2022

Subject: Field Safety Notice – Continued use of older Model 2868 software on Model 3120 ZOOM™ programmers to support transvenous CRT-Ds and ICDs until supply chain constraints on newer programmers¹ are resolved. See Appendix A for affected GTINs (Boston Scientific Field Action Reference: 92822246-FA)

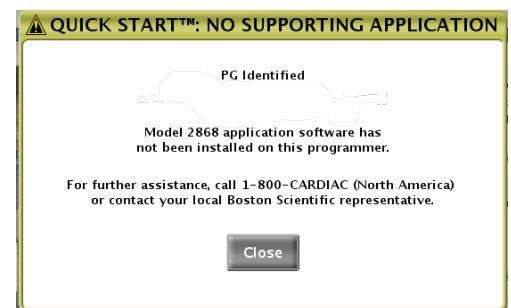
Figure 2. Message that displays when a Boston Scientific TV defibrillator is interrogated by a 3120 ZOOM programmer if 2868 software is uninstalled.

The behavior most likely to be attributed to potential harm when using a 3120 ZOOM programmer is the inability to interrogate a TV defibrillator (e.g. Figure 2 or 3). There have been 9 reports of this behavior which have resulted in a delayed/prolonged procedure until the defibrillator can be interrogated with a 3300 LATITUDE programmer. Furthermore, there has been a single report of delays in reprogramming for phrenic nerve stimulation and a single report of an inability to interrogate for delivery of commanded therapy. None of the reports associated with 3120 ZOOM programmer have resulted in permanent injury.

- 1) If unable to interrogate a TV defibrillator with a 3120 ZOOM programmer, use a 3300 LATITUDE programmer instead. If this behavior occurs, STAT PACE, STAT SHOCK, and DIVERT THERAPY programmer operations⁴ are not available through a 3120 ZOOM programmer, so external pacing/defibrillation or magnet application (to divert shock) may be required if a 3300 LATITUDE programmer is not immediately available.

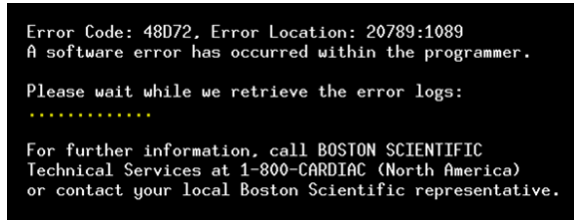
If a TV defibrillator has a stored SAM episode, the 3120 ZOOM programmer will present the Error Log and Halt message in Figure 3, and the user will need to use a 3300 LATITUDE programmer to interrogate the defibrillator. This error message (Figure 3) is an indication of an incompatibility of any 3120 ZOOM programmer with that specific TV defibrillator. However, the TV defibrillator will operate as intended with the permanently programmed settings. After power cycling the programmer, it may be used to interrogate TV defibrillators without stored SAM episodes. If the user attempts to interrogate the same TV defibrillator with the 3120 ZOOM programmer, the Error Log and Halt message will display again.

Figure 3. The specific Error Log and Halt Message on 3120 ZOOM Programmer when interrogation of TV defibrillator with a SAM episode is attempted.

A 3120 ZOOM programmer update to 2868 software has been developed to resolve the Error Log and Halt behavior associated with TV defibrillators having a stored SAM episode. This software update does not represent a material reduction in patient safety risk, however, it does prevent clinical workflow interruptions and will be released subsequent to approval.
