# Important Medical Device Information

December 2017

## Appendix A: Description of Minute Ventilation for the December 2017 MV Product Advisory

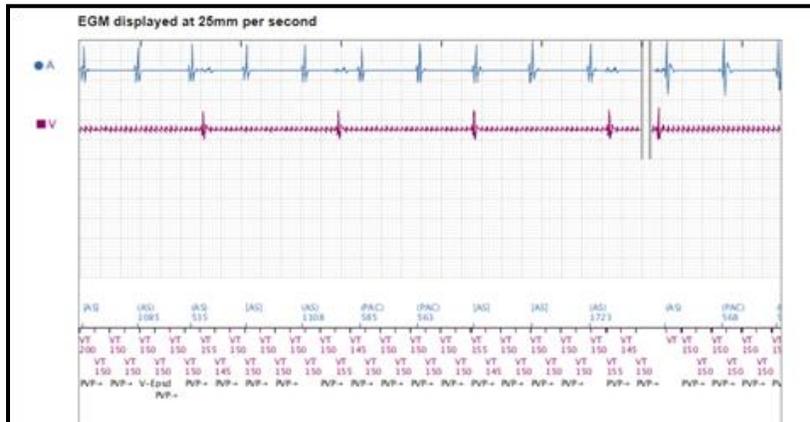
Figure 2. Example of MV signal oversensing

Boston Scientific pacemakers perform an MV lead check approximately every hour to assess lead and lead connection integrity. The active vector may be the primary vector (distal RA ring electrode to the pacemaker case) or secondary vector (distal RV ring electrode to the pacemaker case). Since either vector may be used to measure MV, at least one of the implanted leads must have normal bipolar lead impedances. Typically the MV sensor signal is appropriately filtered out by the pacemaker. However, if a high impedance condition is detected within the lead-pacemaker system, the MV sensor signal may be oversensed (Figure 2).

- For pacemaker-dependent patients, turn the MV sensor “OFF”. Note when programmed to passive, the MV sensor signal is enabled and may be oversensed. See Appendix B for details on turning the MV sensor “OFF”.

- In accordance with the pacemaker manual, if MV sensor signal artifacts are observed on EGMs and leads are performing appropriately, consider programming the sensor to “OFF” to prevent oversensing.
