Urgent Field Safety Notice

January 2019

Subject: Software updates for Cardiac Resynchronization Therapy Defibrillators (CRT-Ds) and Pacemakers (CRT-Ps) address the December 2017 Positive Left Ventricular (LV) Offset Interaction.

Boston Scientific Software Update Addresses Positive LV Offset Interaction

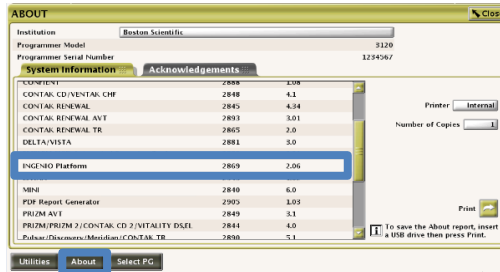
Model 2869 v2.06
Supports CRT-Ps in Table 2

Supported devices interrogated with this software are no longer at risk of permanent Safety Mode status due to a parameter interaction between positive LV Offset, A-Blank after V-Pace values, and Tracking Preference.

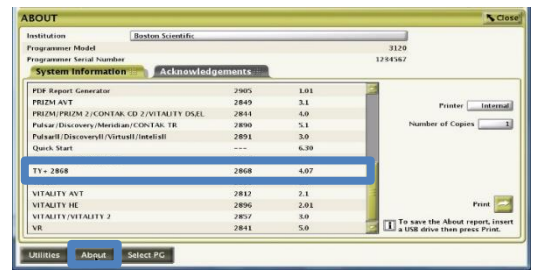
Model 2868 v4.07
Supports CRT-Ds in Table 1
