December 2017

## Appendix A: Description of Minute Ventilation for the December 2017 MV Product Advisory

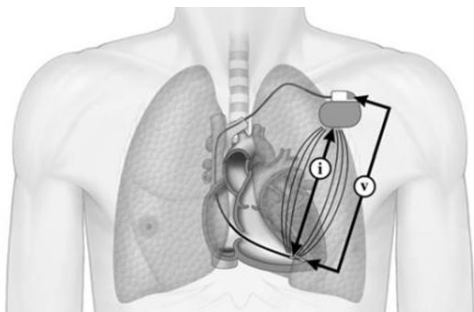
Figure 1. Measurement of the MV Signal from the RV lead

Boston Scientific pacemakers use transthoracic impedance to measure MV which is a product of respiration rate and tidal volume. During inhalation, the increased volume of air in the chest cavity produces an increase in transthoracic impedance. Likewise, during exhalation, the decreased volume of air produces a decrease in transthoracic impedance. Transthoracic impedance measurements are obtained through delivering a subthreshold current waveform approximately every 50 ms between the lead ring electrode and the pacemaker case, and measuring the resultant voltage between the lead tip and the pacemaker case (Figure 1). Boston Scientific pacemakers use the MV sensor for RightRate™ (rate adaptive pacing), Respiratory Rate Trend, and AP Scan™<sup>6</sup>.

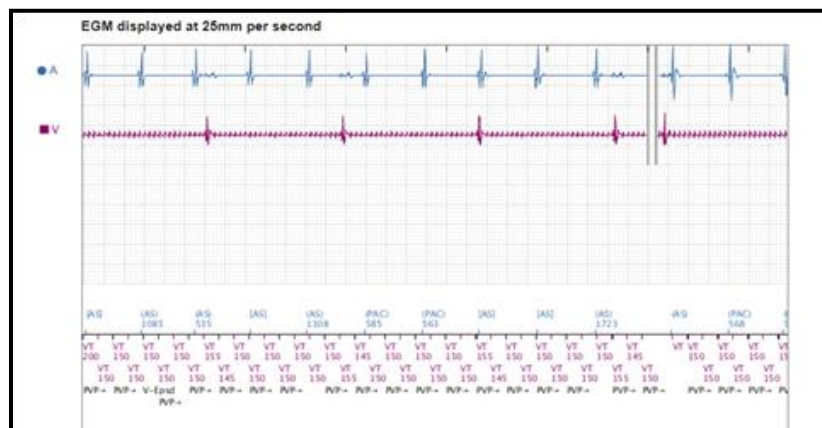
Figure 2. Example of MV signal oversensing

Engineering analysis and testing, as well as evaluation of post-market surveillance data, demonstrates an elevated potential for oversensing of the MV sensor signal in certain pacemaker systems connected to Medtronic or Abbott pacing leads. Although all leads evaluated in simulated testing environments comply with appropriate connector standards<sup>3</sup>, we have discovered subtle differences amongst lead manufacturers in the surface finish of the lead terminal ring and amount of axial and radial terminal ring motion within the pacemaker header. These factors may result in intermittent increases in impedance leading to oversensing of the MV sensor signal or changes in daily impedance test measurements.

Boston Scientific pacemakers perform an MV lead check approximately every hour to assess lead and lead connection integrity. The active vector may be the primary vector (distal RA ring electrode to the pacemaker case) or secondary vector (distal RV ring electrode to the pacemaker case). Since either vector may be used to measure MV, at least one of the implanted leads must have normal bipolar lead impedances. Typically the MV sensor signal is appropriately filtered out by the pacemaker. However, if a high impedance condition is detected within the lead-pacemaker system, the MV sensor signal may be oversensed (Figure 2).

- For pacemaker-dependent patients, turn the MV sensor “OFF”. Note when programmed to passive, the MV sensor signal is enabled and may be oversensed. See Appendix B for details on turning the MV sensor “OFF”.

- In accordance with the pacemaker manual, if MV sensor signal artifacts are observed on EGMs and leads are performing appropriately, consider programming the sensor to “OFF” to prevent oversensing.
