Beeping Tones Associated with “Out-of-Range” Shock Lead Impedance

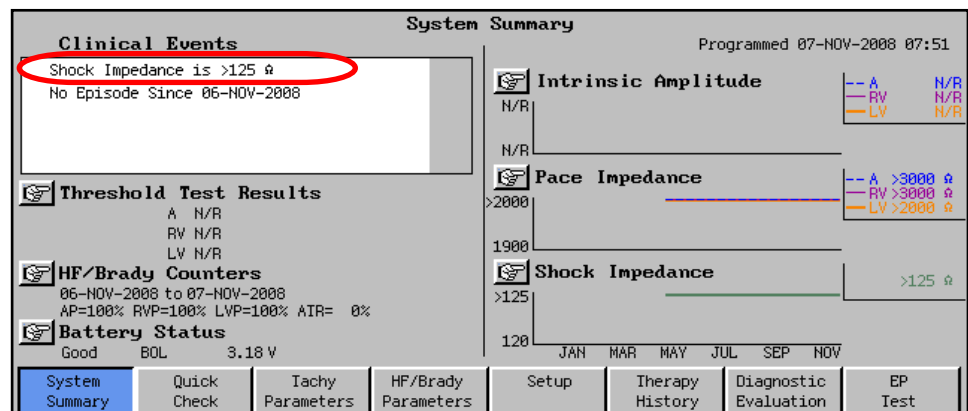
In addition to visual indicators displayed on the programmer (Clinical Events and/or yellow warning messages), some Boston Scientific defibrillators also emit an **audible indicator** to alert patients/clinicians when the device has detected an “out-of-range” shock lead impedance measurement. These two indicators are triggered by impedance measurements of less than 20 ohms (Ω) or greater than 125 Ω .

Figure 1. System Summary screen displaying shock lead impedance outside the normal range.

Any time an out-of-range shock lead impedance condition is reported, clinicians should conduct standard lead testing and troubleshooting procedures to identify root cause and resolve the issue. For assistance with any out-of-range messages, please contact a local Boston Scientific CRM representative or CRM Technical Services.
