Interactions Between Hospital Monitoring or Diagnostic Equipment and Pacemakers Using Minute Ventilation Sensors

SUMMARY

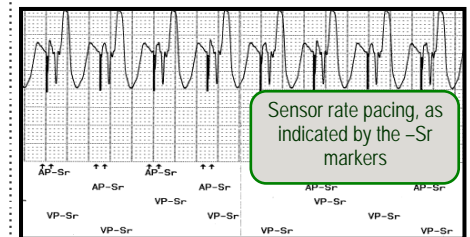
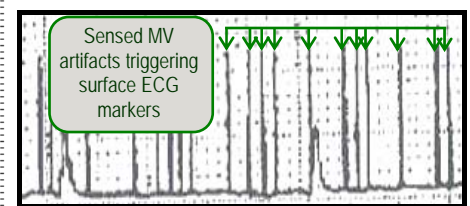
- **External equipment-to-pacemaker interaction.** The pacemaker may detect both the external monitor's test signals and its own impedance test signals, which could result in an inappropriate pacing rate, possibly up to the maximum sensor rate.
- **Pacemaker-to-external equipment interaction.** A surface ECG monitor may sense the implanted pacemaker's MV signals, which may alter diagnostic test results or appear as artifacts on the external surface ECG.

- If a ZOOM® LATITUDE® programmer is available, program the device to a non-rate responsive mode (e.g., DDD), or program the MV feature to Passive or Off.
- If a programmer is not available, apply a magnet to the pacemaker to disregard MV data and pace asynchronously at 100 ppm. Asynchronous pacing will continue as long as the magnet remains positioned over the implanted device.
- **MV should always be programmed Off during mechanical ventilation.**
- If a pacemaker MV signal is triggering artifacts on an external ECG recorder, consider having the pacing spike enhancement feature tuned Off, if appropriate.
