## Important Programmer Information

**Programmer Software Information July 2022** - Continued use of older Model 2868 software on Model 3120 ZOOM™ programmers to support transvenous CRT-Ds and ICDs until supply constraints on newer programmers<sup>1</sup> are resolved. See Table 1 for affected GTINs.

Continued use of Model 3120 ZOOM Programmers for Interrogation of Transvenous Defibrillators

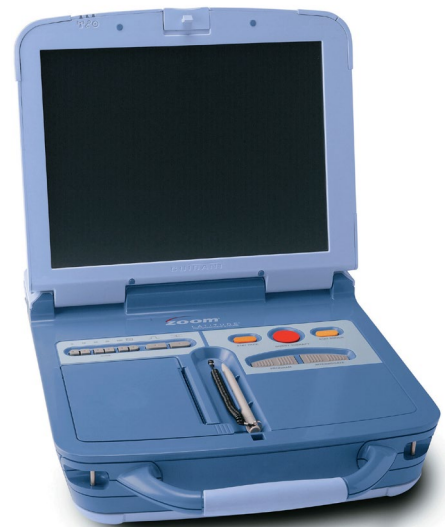
**Figure 1.** Model 3120 ZOOM Programmer

- The 2868 software on the 3120 ZOOM programmer has been uninstalled or is outdated. As such, users may observe unexpected behaviors when attempting communications with transvenous defibrillators<sup>2</sup> including the potential inability to interrogate or the display of incorrect/missing parameters<sup>3</sup>

In facilities whose 3120 ZOOM programmers still have 2868 software installed, there may be unanticipated behaviors observed when interrogating TV defibrillators. The most common behavior observed is an inability to interrogate a TV defibrillator due to a Signal Artifact Monitor (SAM) episode. SAM is one of the new TV defibrillator features included in the enhanced software found on the 3300 LATITUDE programmer. SAM is designed to continually monitor the electrogram for Respiratory/Minute Ventilation (MV) sensor artifacts. If artifacts are detected or sensor vector lead impedance measurements are out of range, SAM either switches the vector or disables the sensor, and a SAM episode is recorded.

- A software update has been developed to resolve some of the disruptive behaviors associated with continued use of 2868 software on the 3120 ZOOM programmer. Boston Scientific will release software after local approval.

- The risk of insufficient programmer supply outweighs the risks associated with these unexpected behaviors, therefore, Boston Scientific recommends continued use of 3120 ZOOM programmers for transvenous defibrillators until sufficient supply of the newer programmers can be achieved locally.

**Recommendations:** Please distribute this letter to all users of the 3120 ZOOM programmer and complete/return the enclosed Customer Acknowledgement Form. Continue using 3120 ZOOM programmers to interrogate Boston Scientific TV defibrillators, as needed, with the following in mind:
