July 2022

Subject: Field Safety Notice – Continued use of older Model 2868 software on Model 3120 ZOOM™ programmers to support transvenous CRT-Ds and ICDs until supply chain constraints on newer programmers¹ are resolved. See Appendix A for affected GTINs (Boston Scientific Field Action Reference: 92822246-FA)

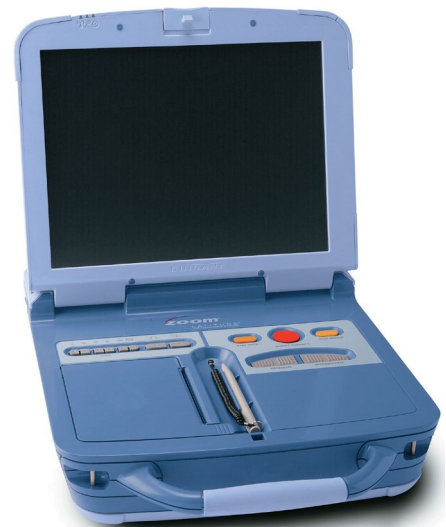
Figure 1. Model 3120 ZOOM Programmer

- The 2868 software on the 3120 ZOOM programmer has been uninstalled or is outdated. As such, users may observe unexpected behaviors when attempting communications with transvenous defibrillators² including the potential inability to interrogate or the display of incorrect/missing parameters³

In facilities whose 3120 ZOOM programmers still have 2868 software installed, there may be unanticipated behaviors observed when interrogating TV defibrillators. The most common behavior observed is an inability to interrogate a TV defibrillator due to a Signal Artifact Monitor (SAM) episode. SAM is one of the new TV defibrillator features included in the enhanced software found on the 3300 LATITUDE programmer. SAM is designed to continually monitor the electrogram for Respiratory/Minute Ventilation (MV) sensor artifacts. If artifacts are detected or sensor vector lead impedance measurements are out of range, SAM either switches the vector or disables the sensor, and a SAM episode is recorded.

- A software update has been developed to resolve some of the disruptive behaviors associated with continued use of 2868 software on the 3120 ZOOM programmer. Boston Scientific will release software after local approval.

Recommendations: Please distribute this letter to all users of the 3120 ZOOM programmer and complete/return the Acknowledgment Form. Continue using 3120 ZOOM programmers to interrogate Boston Scientific TV defibrillators, as needed, with the following in mind:
