# Important Medical Device Information

December 2017

## Appendix A: Description of Minute Ventilation for the December 2017 MV Product Advisory

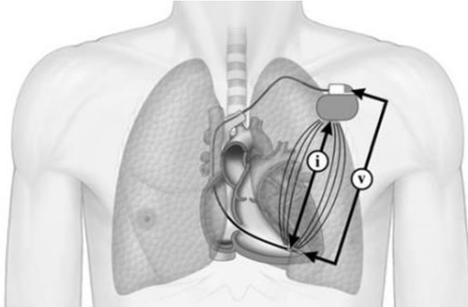
Figure 1. Measurement of the MV Signal from the RV lead

Boston Scientific pacemakers perform an MV lead check approximately every hour to assess lead and lead connection integrity. The active vector may be the primary vector (distal RA ring electrode to the pacemaker case) or secondary vector (distal RV ring electrode to the pacemaker case). Since either vector may be used to measure MV, at least one of the implanted leads must have normal bipolar lead impedances. Typically the MV sensor signal is appropriately filtered out by the pacemaker. However, if a high impedance condition is detected within the lead-pacemaker system, the MV sensor signal may be oversensed (Figure 2).

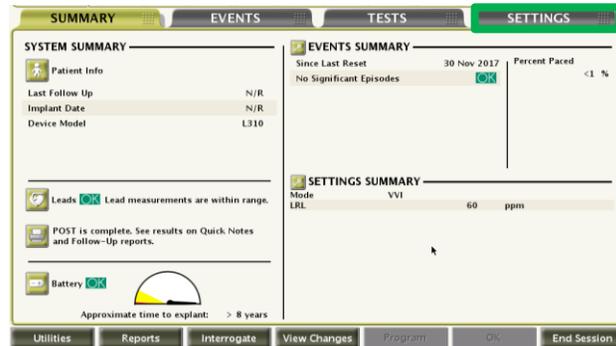
1. On the Summary page, select

“Settings” Tab

For all affected pacemakers and INTL affected CRT-PS, turn the MV Sensor “OFF” by disabling it within the Rate Adaptive Pacing settings

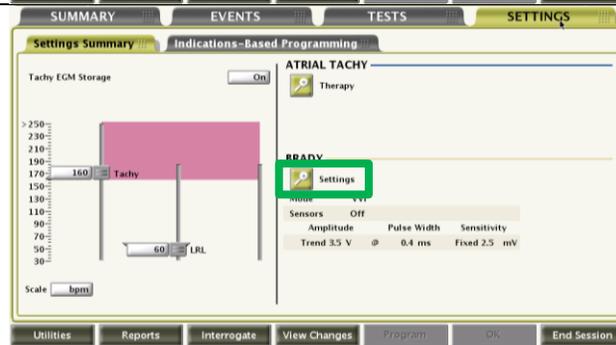
2. On Settings Summary Tab, in the Brady section select

“Settings” button

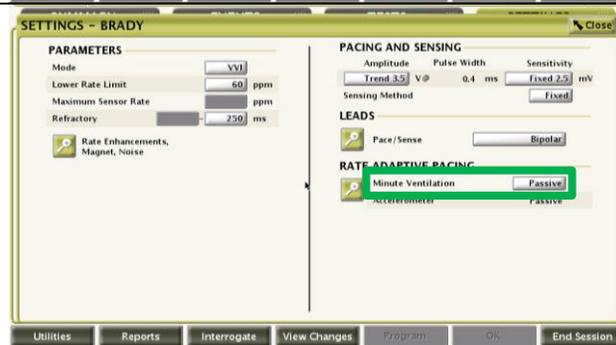
3. On Settings – Brady page, in the Rate Adaptive Pacing section, review the Minute Ventilation programmed value.

If the value is “Passive” or “ON” the MV sensor is enabled.

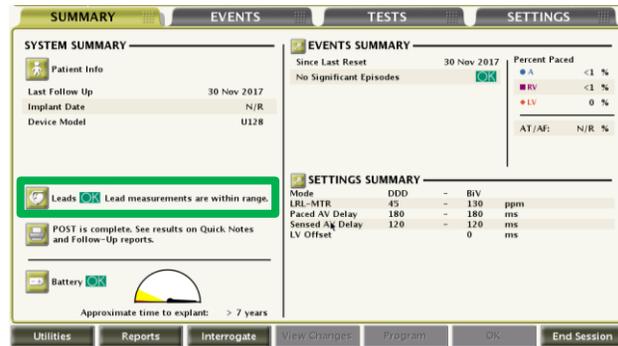
1. On the Summary page, select

“Leads” Button

For US configurations of affected CRT-PS, turn the MV Sensor “OFF” by disabling Respiratory Rate Trend.

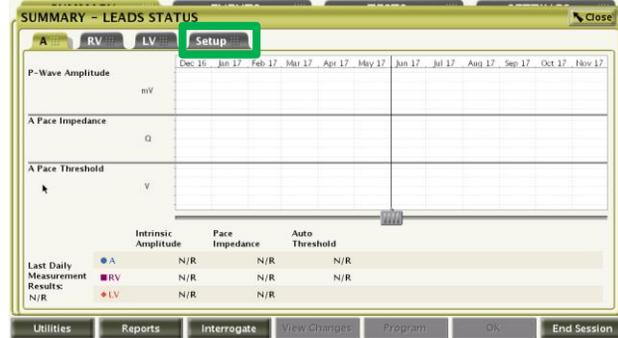
2. On the Summary – Leads Status page, select

“Setup” Tab

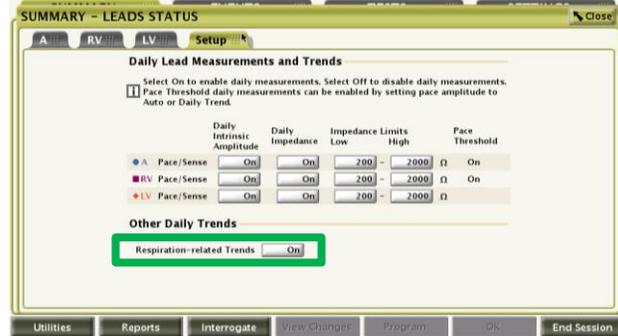
3. On the Summary – Leads Status page, in the Other Daily Trends section, review the Respiration-related Trends value.

If the value is “ON” the MV sensor is enabled.
