December 2017

## Appendix A: Description of Minute Ventilation for the December 2017 MV Product Advisory

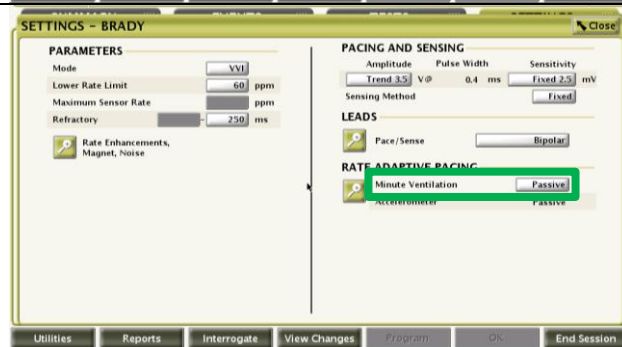
3. On Settings – Brady page, in the Rate Adaptive Pacing section, review the Minute Ventilation programmed value.

If the value is “Passive” or “ON” the MV sensor is enabled.

4. To eliminate the potential for oversensing the MV sensor signal, program the Minute Ventilation Sensor to “OFF”
