POLARxTM Cryoablation System

Troubleshooting Guide

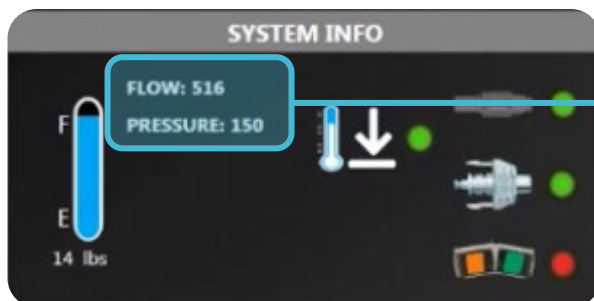
During inflation, Pressure should be $150\text{psig} \pm 5$

Flow rate varies, but if <700 , as shown here, indicates poor system performance

To help diagnose the cause of the error, it is important to monitor Flow/Pressure history during the procedure from the System Info section in the bottom right of the Therapy Screen.

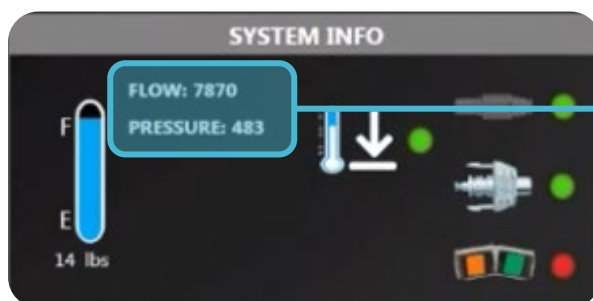
During ablation, N₂O flow rate should be 7800 ± 400

Pressure varies, but if >550 and increases with successive ablations, may indicate poor catheter performance

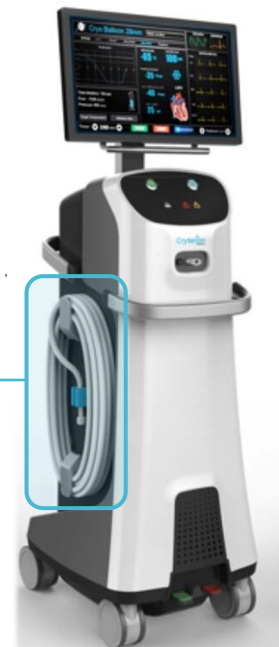
Scavenging Line

1. Ensure scavenging hose is securely attached at console and wall adapter.
2. Ensure hospital scavenging system is working properly.
3. If problem persists, contact BSC Europe Technical Assistance Center at 00800 5555 7707. (See full list of TAC Numbers by Country on [Pg 29](#))

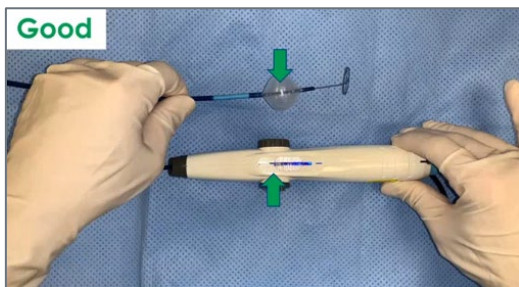
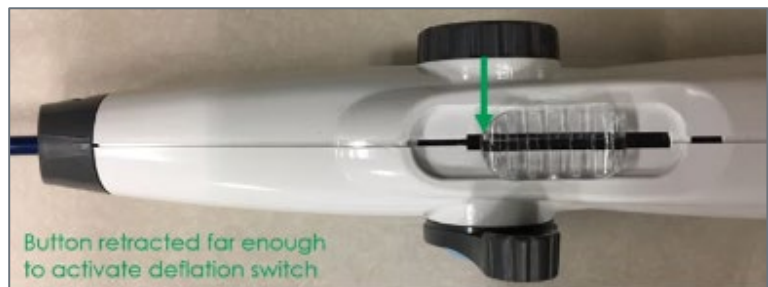
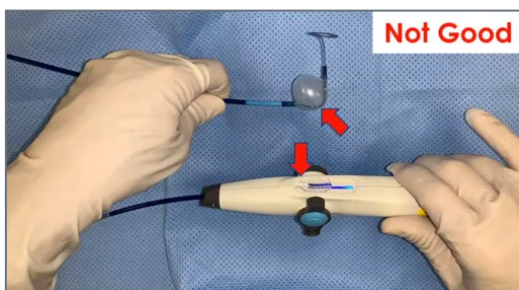
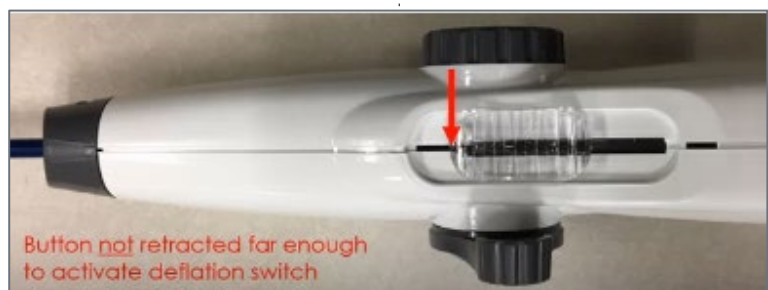
- The guidewire lumen is a sheath within the sheath. At the proximal end, it is connected to the slider switch and ends distally at the tip of the catheter.
- When the balloon inflates, the lumen shortens and pushes the slider switch back to a neutral position on handle.
- On occasion, the slider switch may meet resistance in the shaft and does not move back completely.
- If it doesn't move back into its resting slot in the neutral position, the guidewire lumen may bend or buckle.

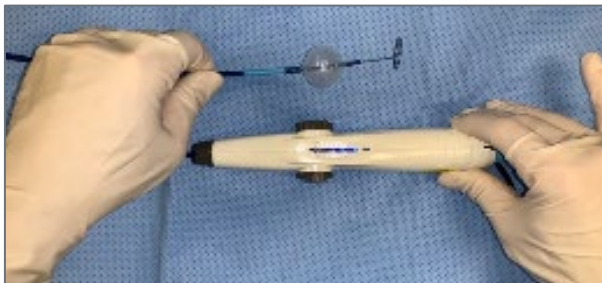
“Standard” Prep (mapping catheter more proximal)

Best Practice to prevent buckling during catheter preparation:

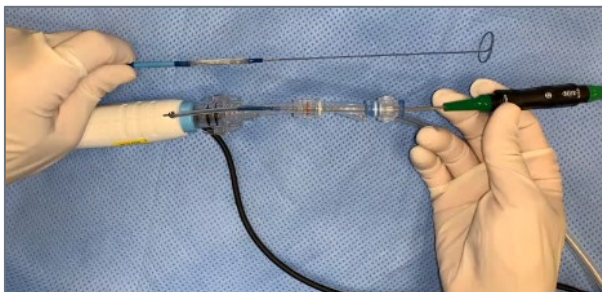
“More Support” Prep (mapping catheter more distal)

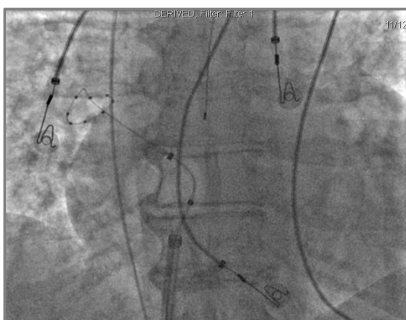
Example 1:
Guidewire lumen buckling
(lumen displaced from center)

1. Do not push slider switch forward.
2. Manually pull slider switch back as far as possible.
3. Observe catheter under fluoroscopy to make sure guidewire lumen is straightened.
4. If corrected, proceed with procedure.
5. If not corrected, deflate the catheter using the slider switch to reposition.

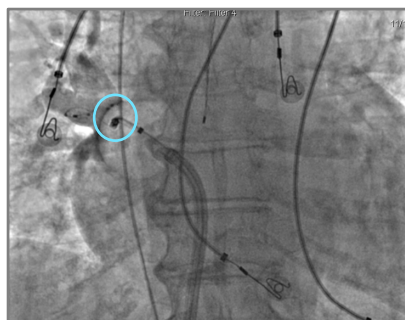
Example 2:
Guidewire lumen buckling

**Catheter should be repositioned
prior to ablation**

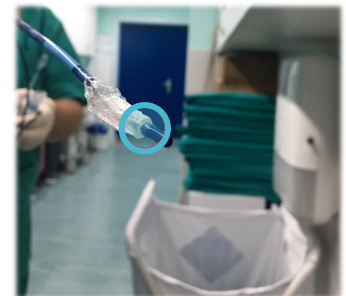
1. Inflate and use the slider switch to deflate and extend the balloon.
2. Check fluoro or other imaging modality to identify if, and where, there is a possible obstruction (see image).
3. Perform another inflation and deflation cycle maintaining strong forward pressure on the slider switch while attempting to re-sheath.
4. If difficulty persists and access to the LA is still needed, exchange the POLARMAP™ Circular Mapping Catheter for a guidewire (>220cm) and advise physician to remove POLARSHEATH Introducer Sheath and POLARx Catheter together from the groin.

Possible distal “bunching”

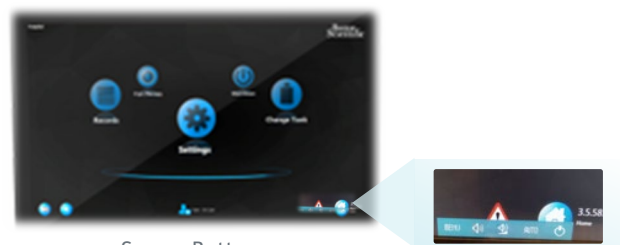
Cable Connections/Back of Monitor

Screen Buttons

1. Power down and reboot the SMARTFREEZE Console.
2. Check monitor for loose cable connections on the back/ underneath side of the monitor.
3. Power on the console.
4. Ensure the green power light is illuminated.
 - If not, touch the small rectangular power button on the bottom right corner of the monitor.
5. Reboot system.
6. If problem persists, contact BSC Europe Technical Assistance Center at 00800 5555 7707. (See full list of TAC Numbers by Country on [Pg 29](#))

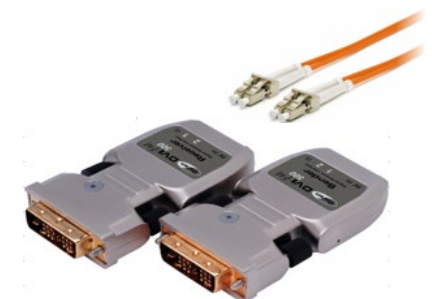
HDMI Cable

DVI Adapters

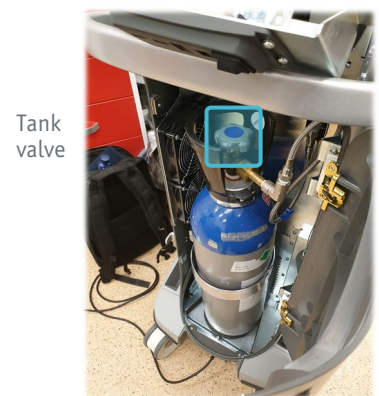
1. Open back of console and ensure tank valve is completely open.
2. Turn on console, change tank, close door, and let tank warm.
 - Enter 'Change Task' and observe tank pressure. Pressure should be greater than 680psig.
3. If insufficient pressure once tanks is warm, change tank.
4. If problem persists, contact BSC Europe Technical Assistance Center at 00800 5555 7707. (See full list of TAC Numbers by Country on [Pg 29](#))

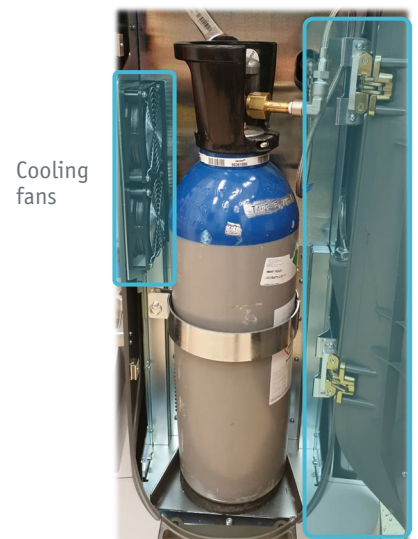
1. Open back of console to allow cooling of the compartment (may take several minutes).
2. Ensure the fans are running.
3. If problem persists, reboot console.
4. If the alarm happens when a new tank is installed, the tank may be overfull. Install the tank as normal and follow the Change Tank procedure twice. This will siphon off some of the gas in the tank.
5. If problem persists, contact BSC Europe Technical Assistance Center at 00800 5555 7707. (See full list of TAC Numbers by Country on [Pg 29](#))

Cooling fans

Tank compartment door

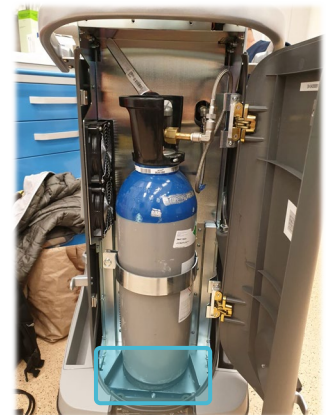
1. Open back of console and slightly reposition the tank on the scale.
 - Reevaluate tank weight reading to see if it was corrected.
2. Ensure unwarranted items (lab supplies) are not resting on top of the tank or scale, or that console door is not impinging the console tank hose.
3. Ensure the console tank hose is not exerting any additional weight on the tank.
4. Ensure the tank selected in the software matches the tank being used. If this is incorrect, the new weight must be entered, system rebooted, and the on-screen tank change process completed for the system to accept the changes.
5. If problem persists, contact BSC Europe Technical Assistance Center at 00800 5555 7707. (See full list of TAC Numbers by Country on [Pg 29](#))

Tank Scale

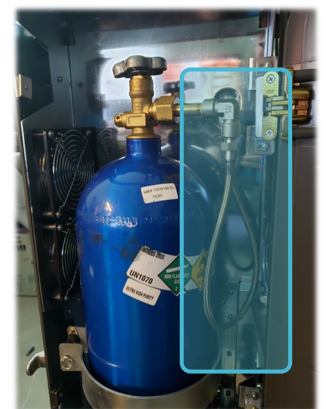
Appropriate console tank hose looping

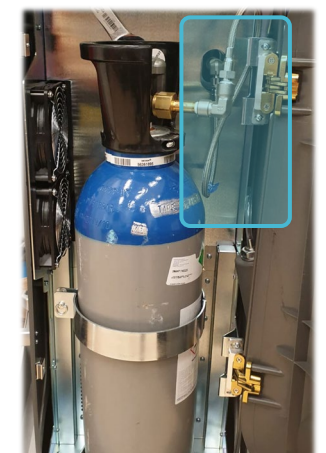
Inappropriate console tank hose looping may exert additional weight on the tank scale

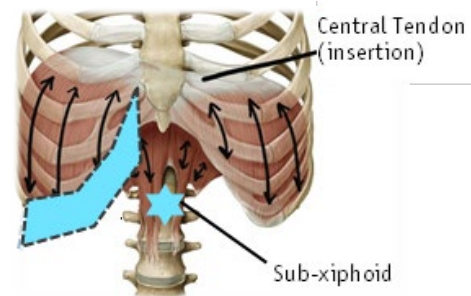
- ★ Place DMS sensor 2-4cm subxiphoid or right subcostal (blue area) where max inhalation/exhalation breathing pattern is noted or max movement when patient instructed to cough.
