Urgent Field Safety Notice

Cardiac Rhythm Management

Subject: Urgent Field Safety Notice Software Update – Minute Ventilation Sensor Software Update Available for Pacemakers Ref: 92186345-FA.

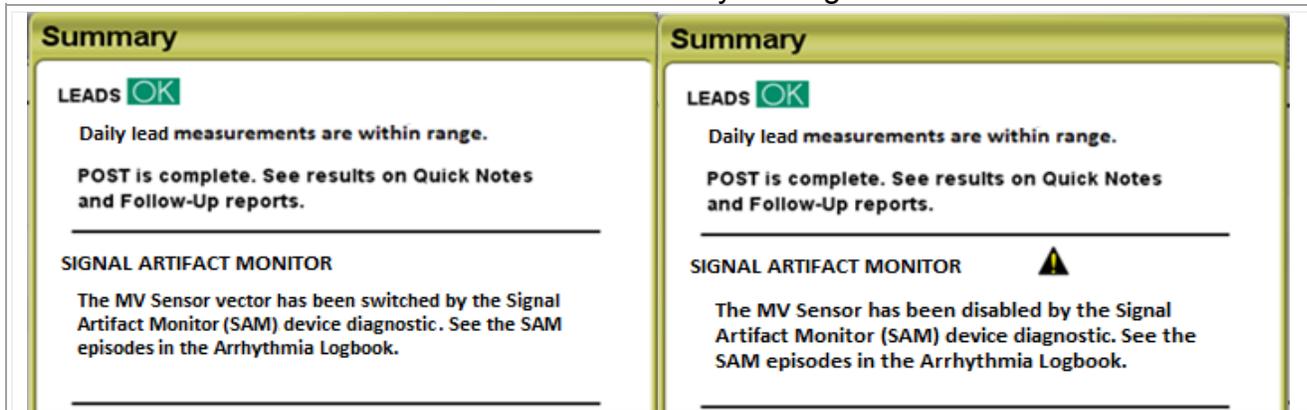
Figure 1. Summary dialogue presented at the next programmer interrogation after the MV sensor vector has been switched or MV disabled by the Signal Artifact Monitor.

1) with associated episodes available within the arrhythmia logbook for review. A future LATITUDE NXT Remote Patient Management system release will enable the user to view SAM parameters/episodes and receive a yellow alert if SAM disables the MV sensor.

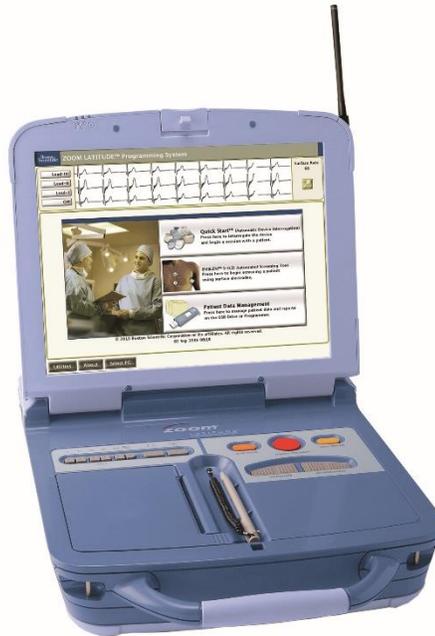
Model 3120 ZOOM™ Programmer

Confirm software upgrade

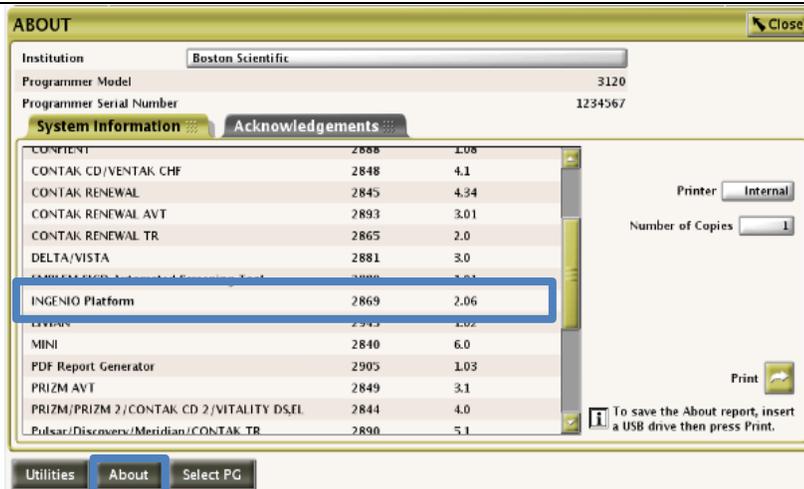
Select About button and Confirm Software Model and Version

Confirm Model 2869 v2.06 is installed on the About Screen
